APPENDIX 1 – SOLUTIONS – PONTOONS

How could everyone have been saved? Could pontoons have worked?

The plan – build pontoons which can carry more people

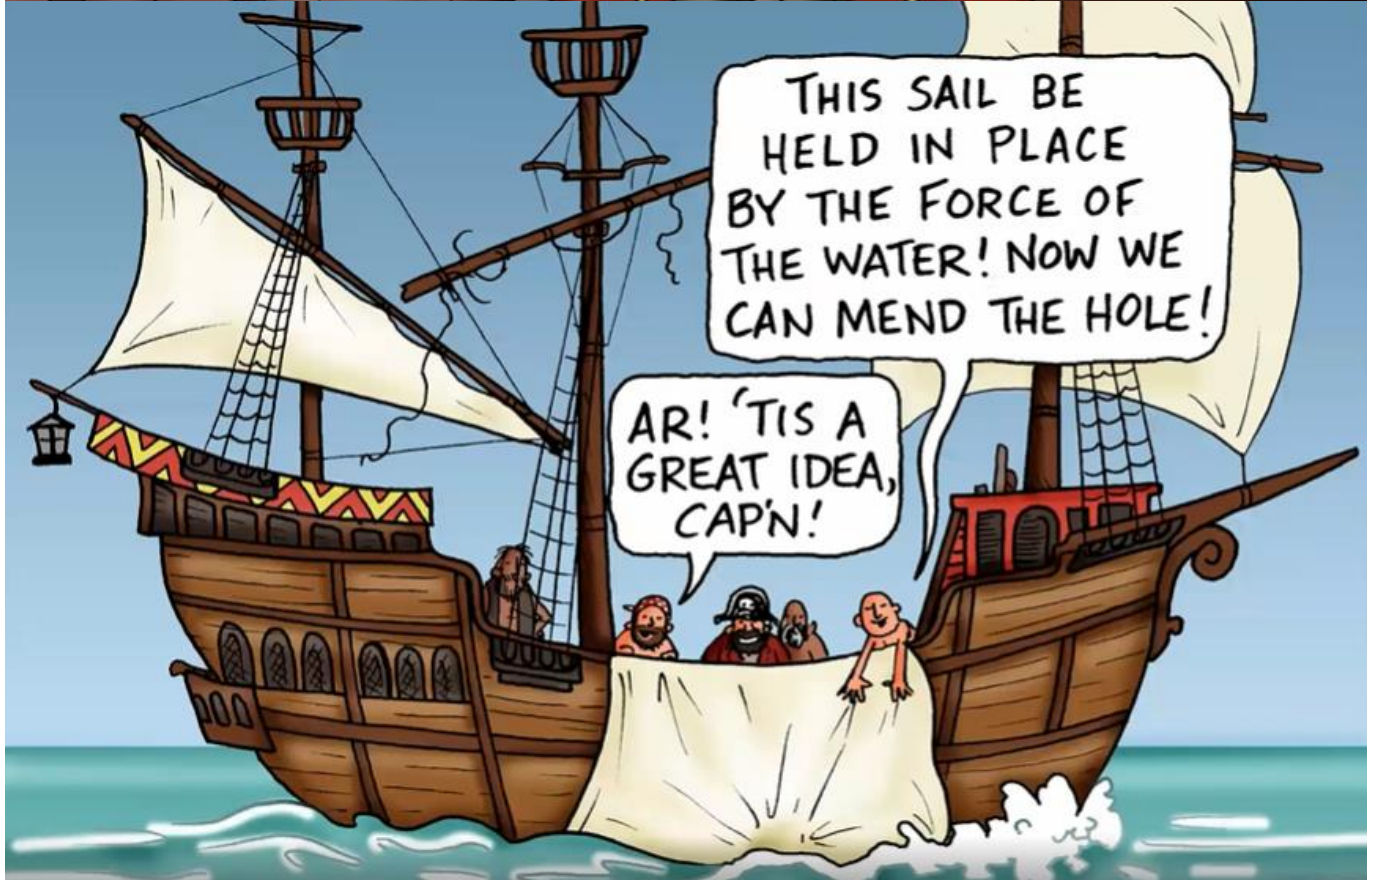
Fothering – A history – Shipwreck of Endeavour. 1770

Endeavour beached at its namesake river, Endeavour River, for repairs after her grounding on the Great Barrier Reef in 1770. By Johann Fritzs, published 1786.

Endeavour then resumed her course northward and parallel to the reef, the crew looking for a safe harbour in which to make repairs. On 13 June, the ship came to a broad watercourse that Cook named the Endeavour River.[54] Cook attempted to enter the river mouth, but strong winds and rain prevented Endeavour from crossing the bar until the morning of 17 June. She grounded briefly on a sand spit but was refloated an hour later and warped into the river proper by early afternoon. The ship was promptly beached on the southern bank and careened to make repairs to the hull. Torn sails and rigging were also replaced and the hull scraped free of barnacles.[55]

An examination of the hull showed that a piece of coral the size of a man's fist had sliced clean through the timbers and then broken off. Surrounded by pieces of oakum from the fother, this coral fragment had helped plug the hole in the hull and preserved the ship from sinking on the reef.[56]

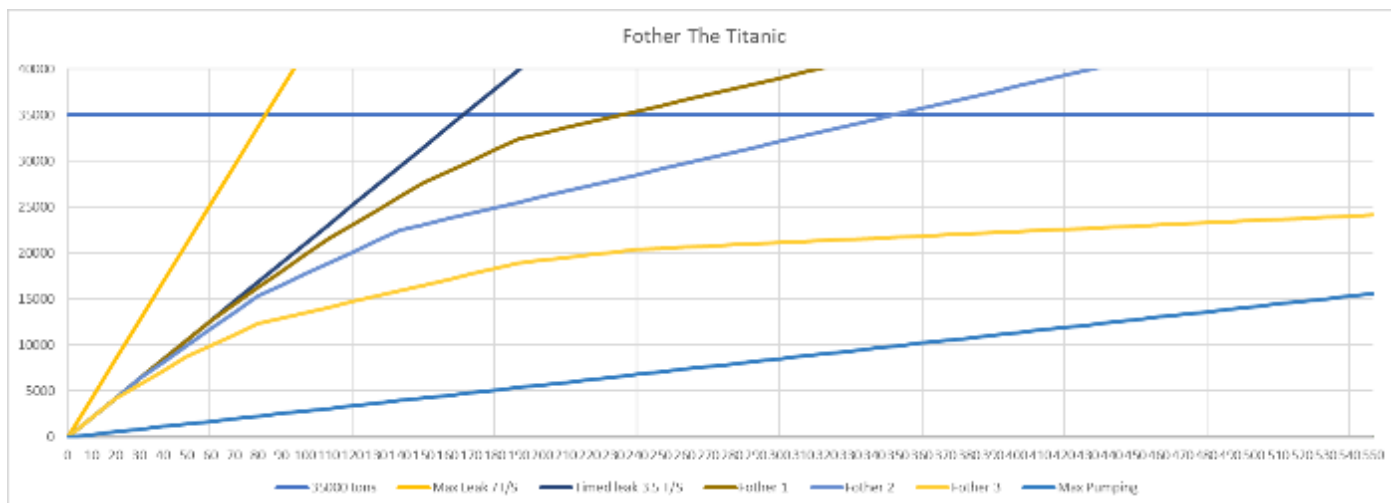
This chart indicates that even limited success with fothering would have bought more time.

The leak rate is understood to have been 3.5 ton per second and that the ship sank when 35,000 tons of water had come on board – although the figures provided are very mixed and inconsistent. However, it is clear that the ship remained afloat for 2 hours and 40 minutes and that whatever the eventual volume of water, the ratio between the incoming flow and the amount that entered would be the same, and the ship overcome in 10,000 seconds
